**Spartanburg District Five  
Athletic Assessments**

# Assessment Process

## Condition Classifications

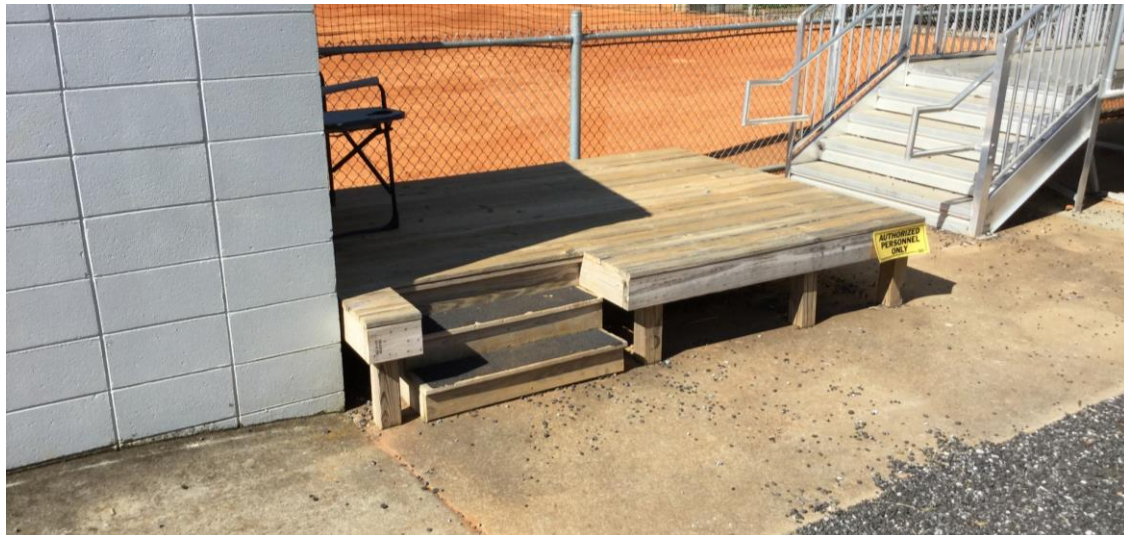
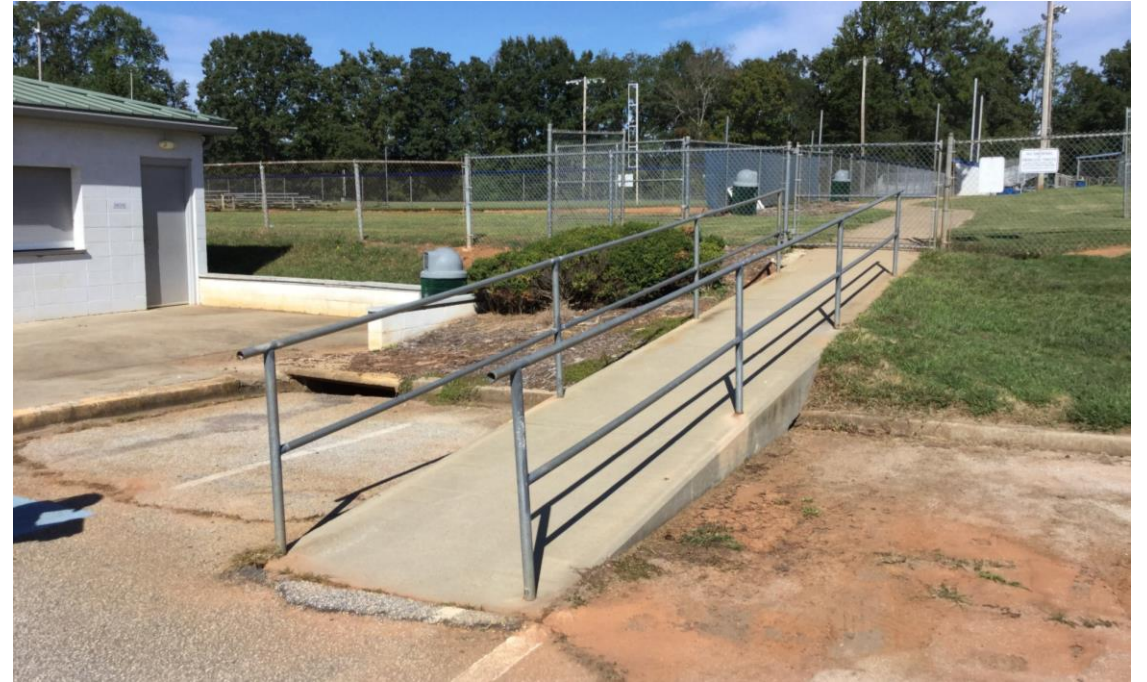
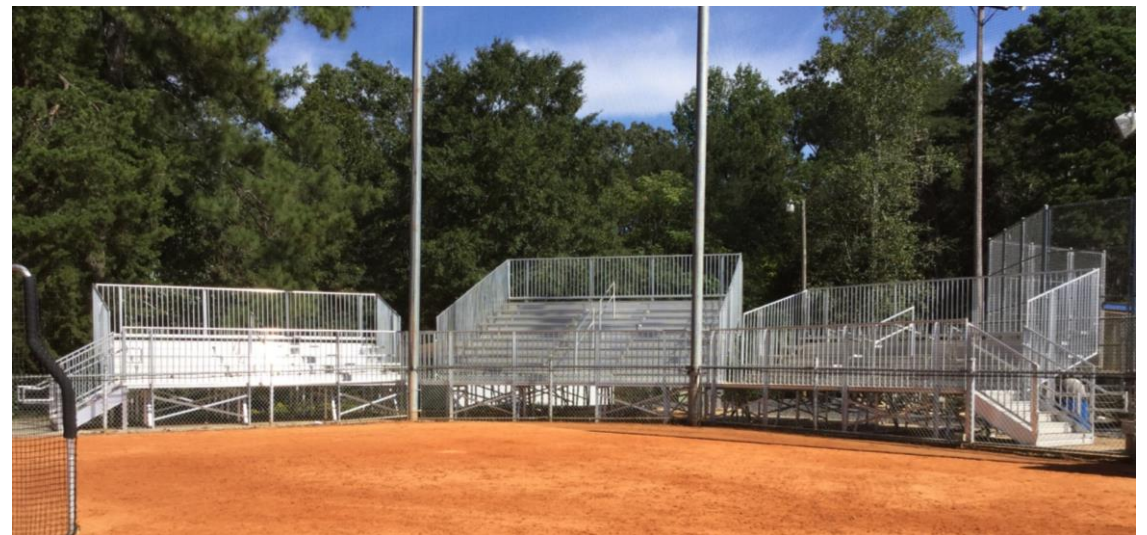
### Softball Complex – Overall Fair Condition

- Overall ADA compliance is in **critical condition**
  - Accessibility to the fields, accessibility to the seating area, and accessible seating
- No press box
- Competition field spectator seating is not accessible
- Practice field spectator seating is not accessible and does not provide sufficient sight lines

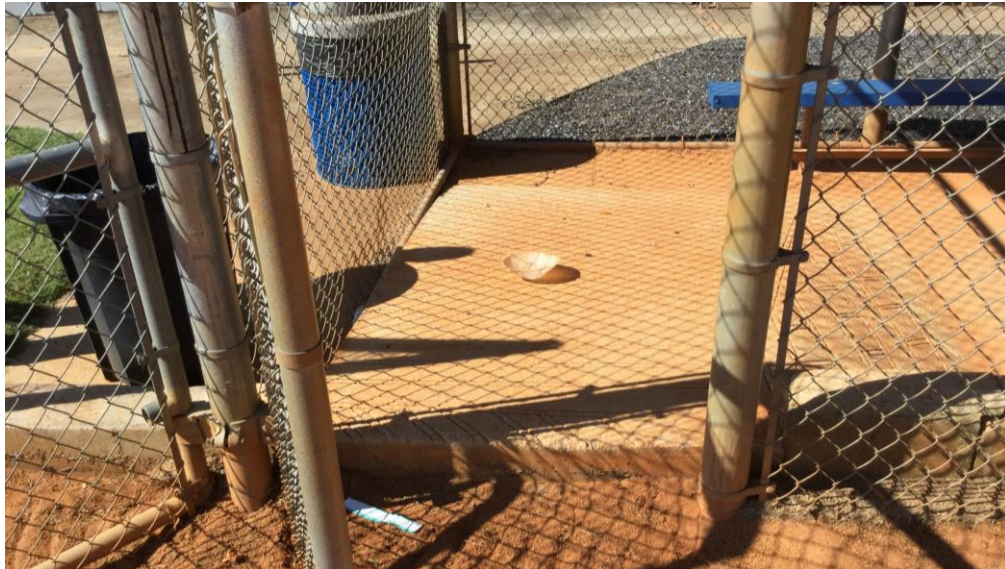
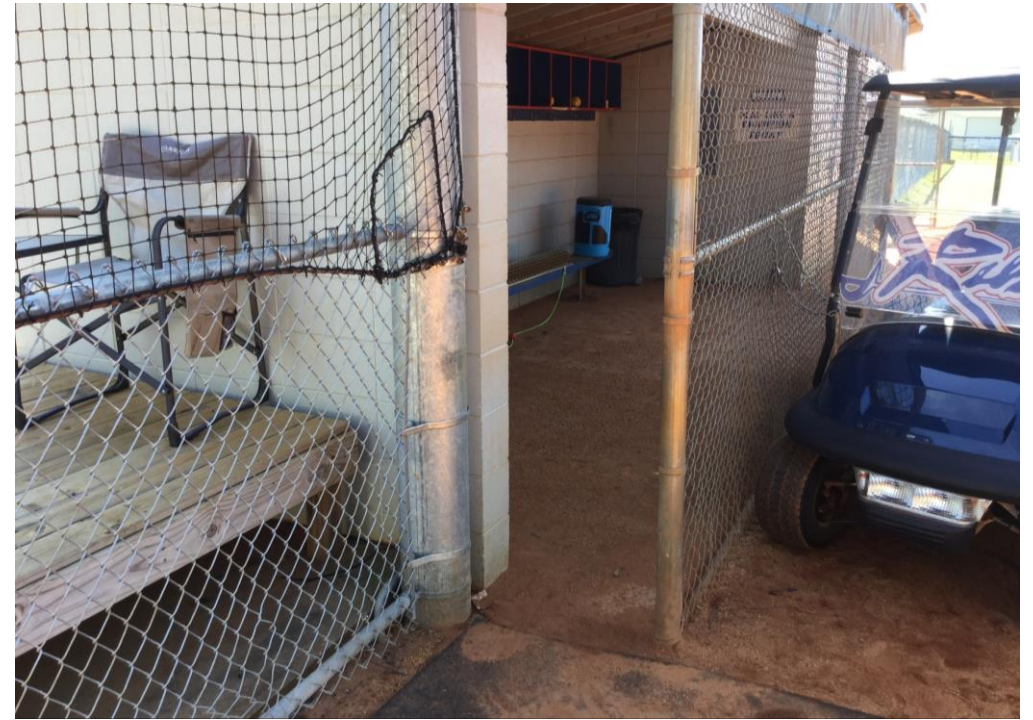
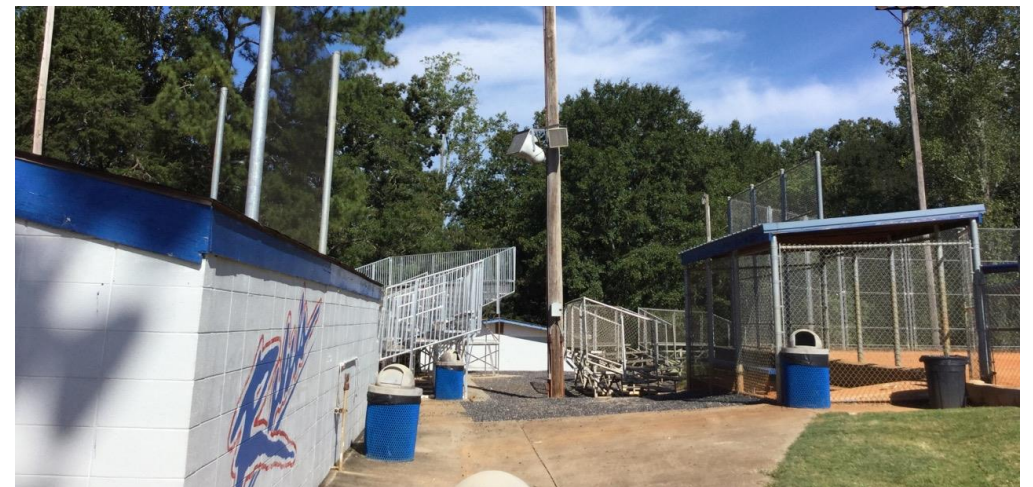
### Softball Complex – Overall Fair Condition

- PA System is **fair condition**
- Safety issue for foul balls between fields
- Competition field dugouts are in **poor condition**
- Practice field dugouts are in **critical condition**
- Competition field orientation is in **critical condition**
- Lacking sufficient storage area

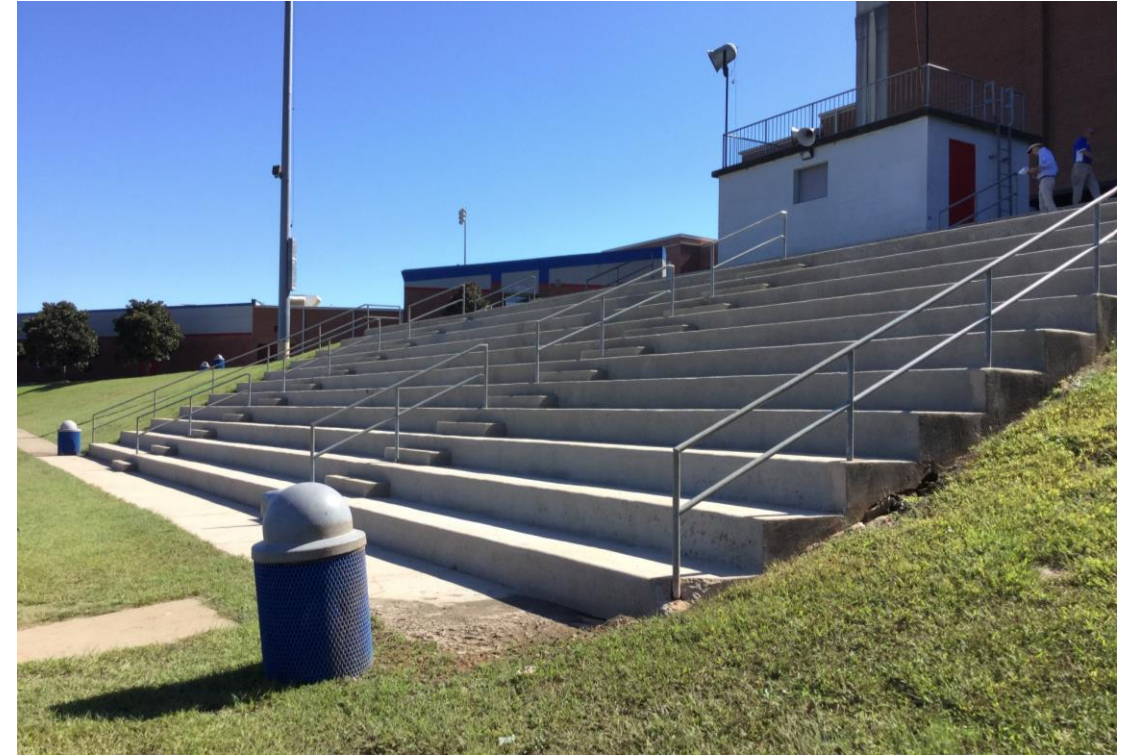
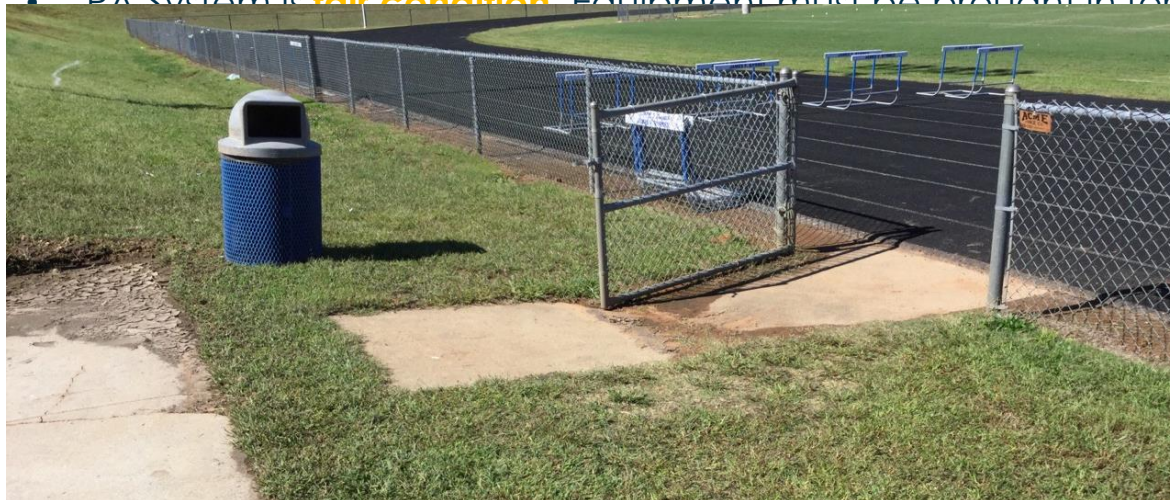
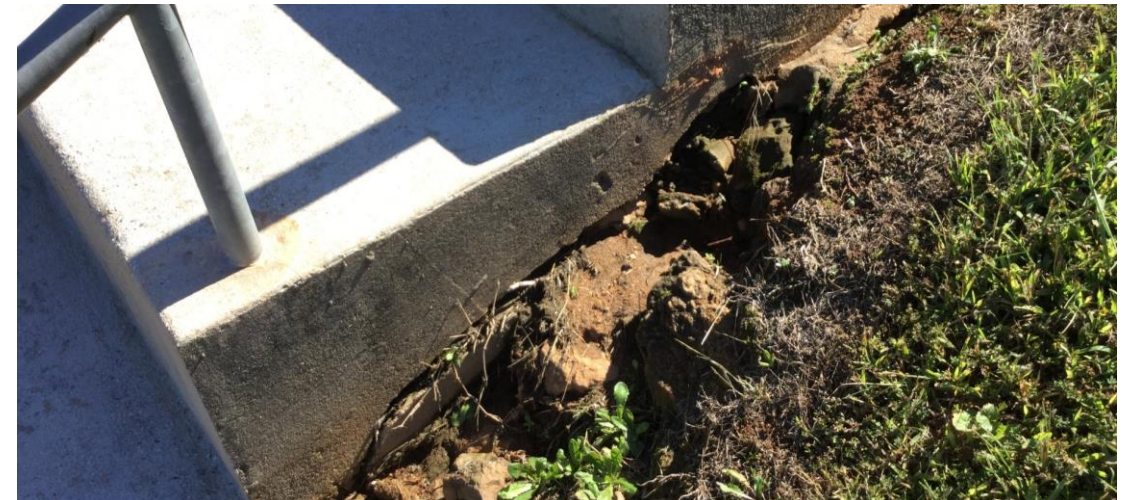
### Byrnes High School Track & Soccer Complex – Overall Good Condition

- Overall ADA compliance is in **poor condition**
  - There is not an accessible path to the handicap seating area
  - Guardrail and companion seating are missing from handicap seating area
- Spectator seating is in **good condition**. Water has begun to erode the side of the concrete seating and should be addressed soon.
- PA System is **fair condition**. Equipment must be brought in for

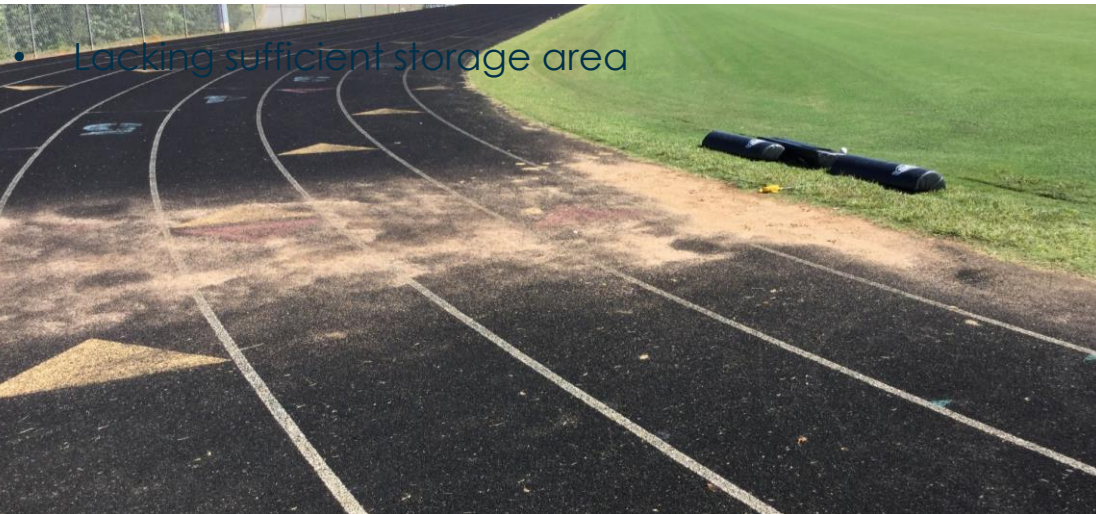
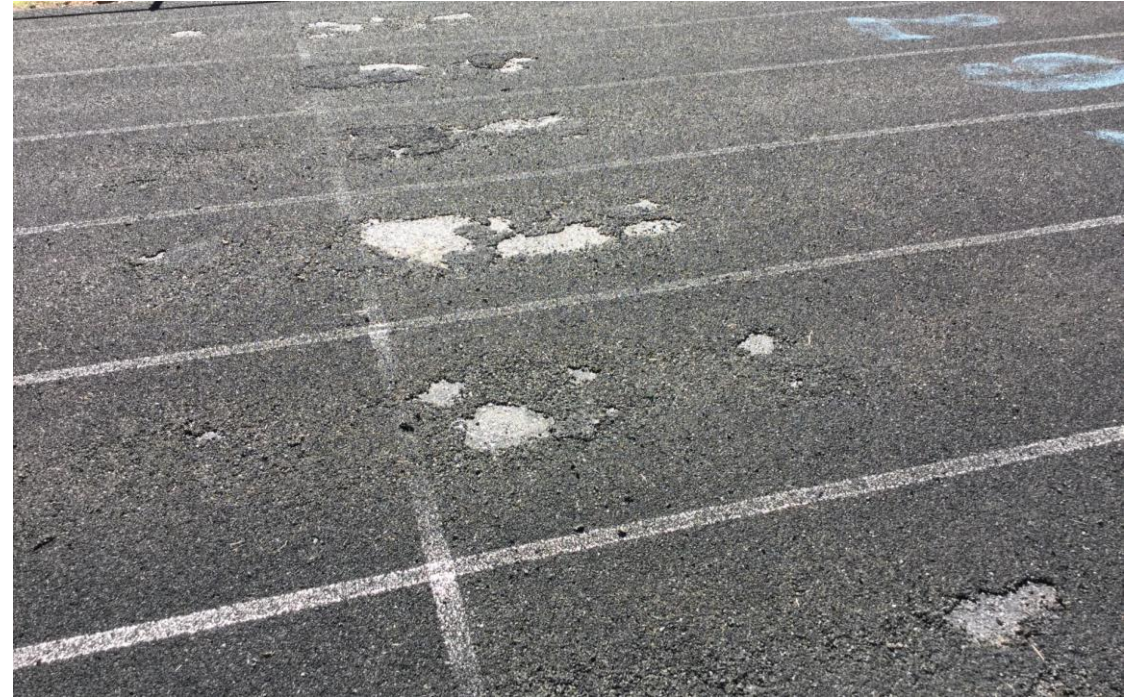
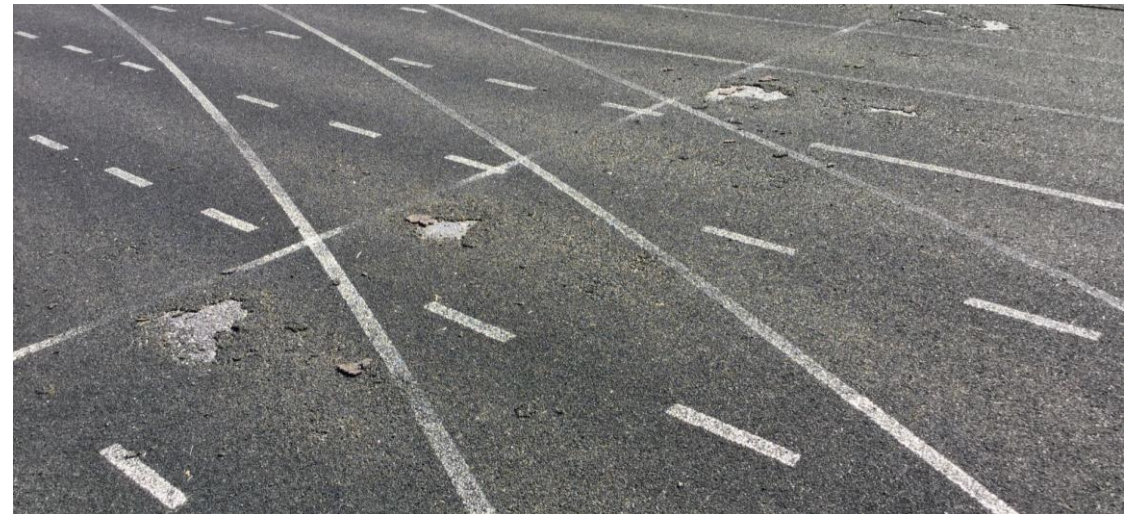
### Byrnes High School Track & Soccer Complex – Overall Good Condition

- Rubber track surface is in **critical condition**—last resurfaced in 2013
  - Multiple start line locations have been worn down to the asphalt sub-base
  - Entirety of track rubber has been worn down to below 1/4" thickness
- Soccer field is in **good condition** however, it is used by so many different sports that it tends to be worn down by soccer season

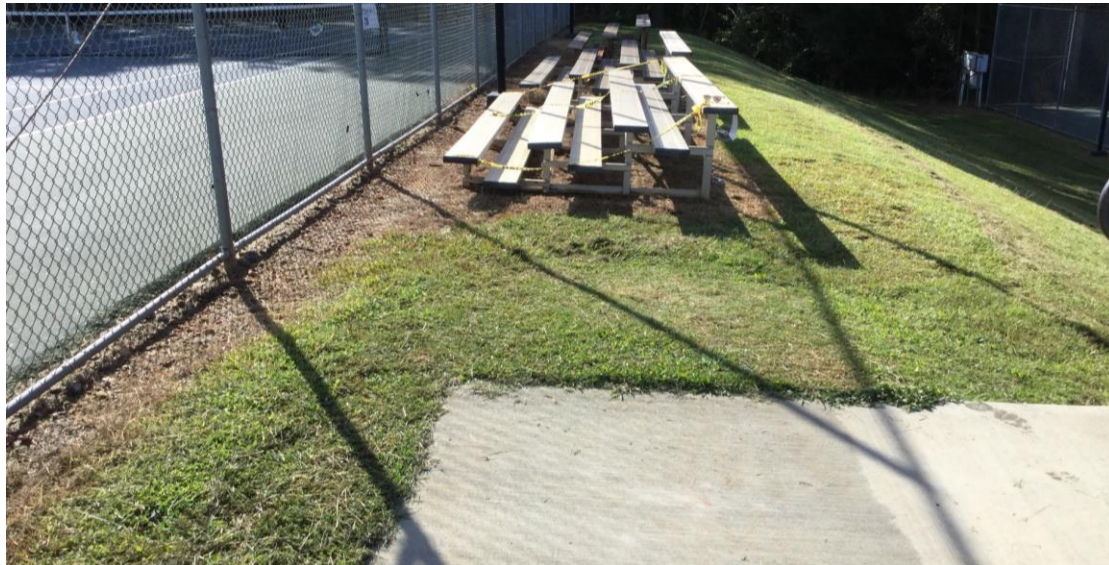
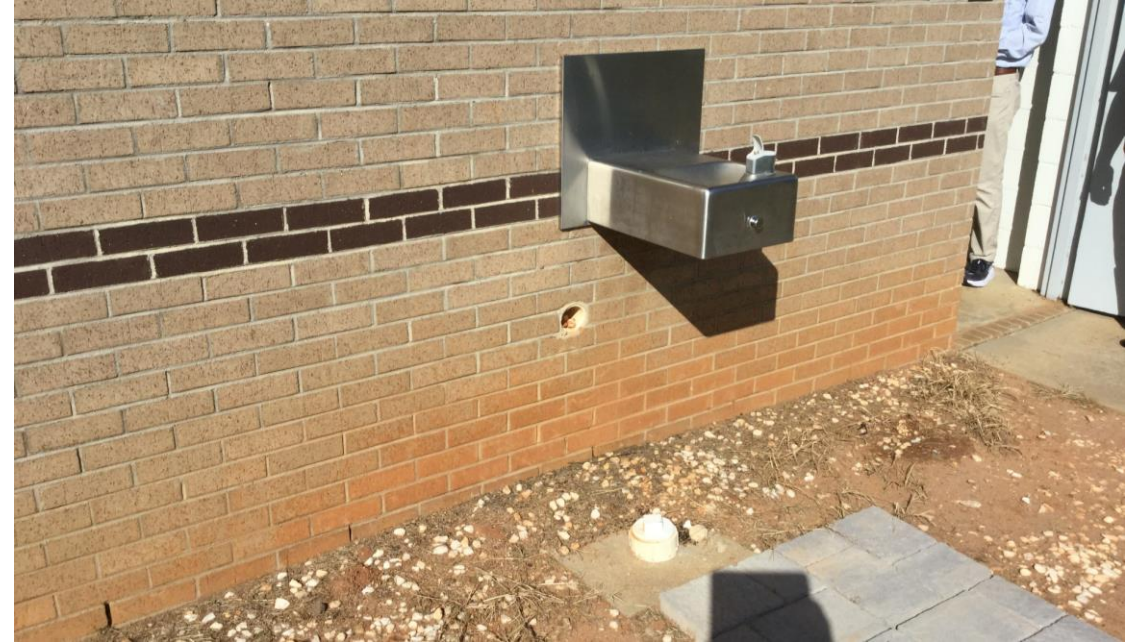
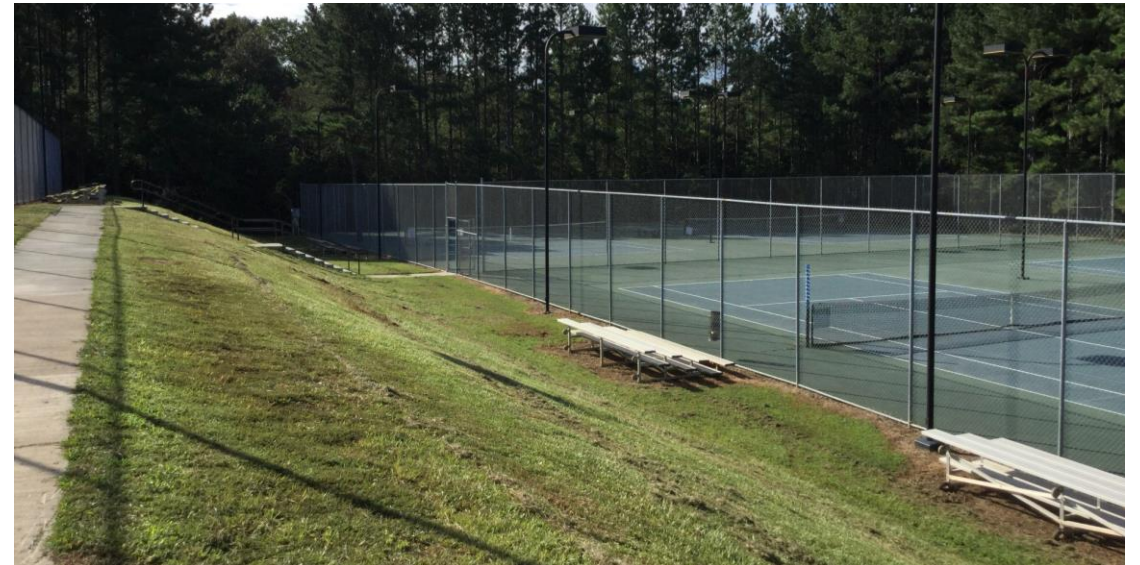
### Tennis Complex – Overall Fair Condition

- Overall ADA compliance is in **poor condition**
  - There is not an accessible path to the seating area
  - There is no accessible seating
- Spectator seating is in **fair condition**
  - Aluminum bleachers are not accessible
  - Concrete base and concrete path to the seating area is recommended

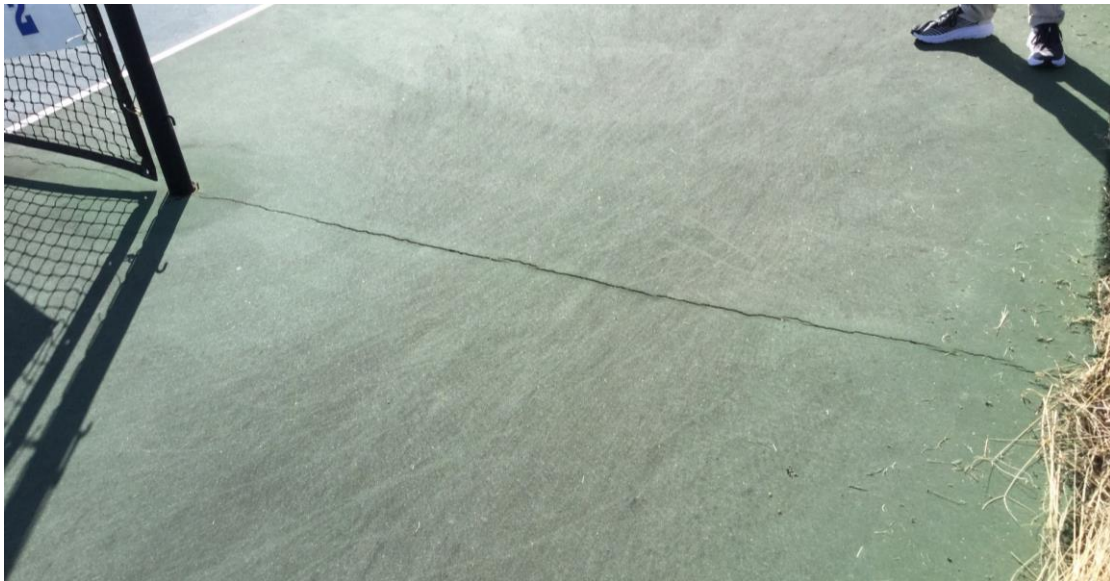
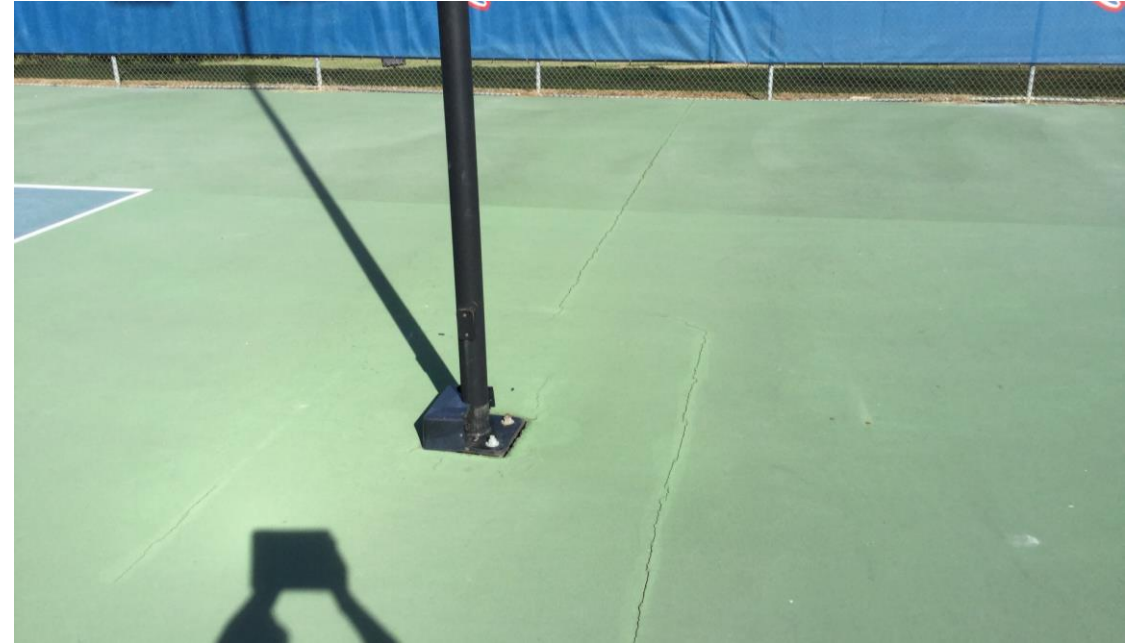
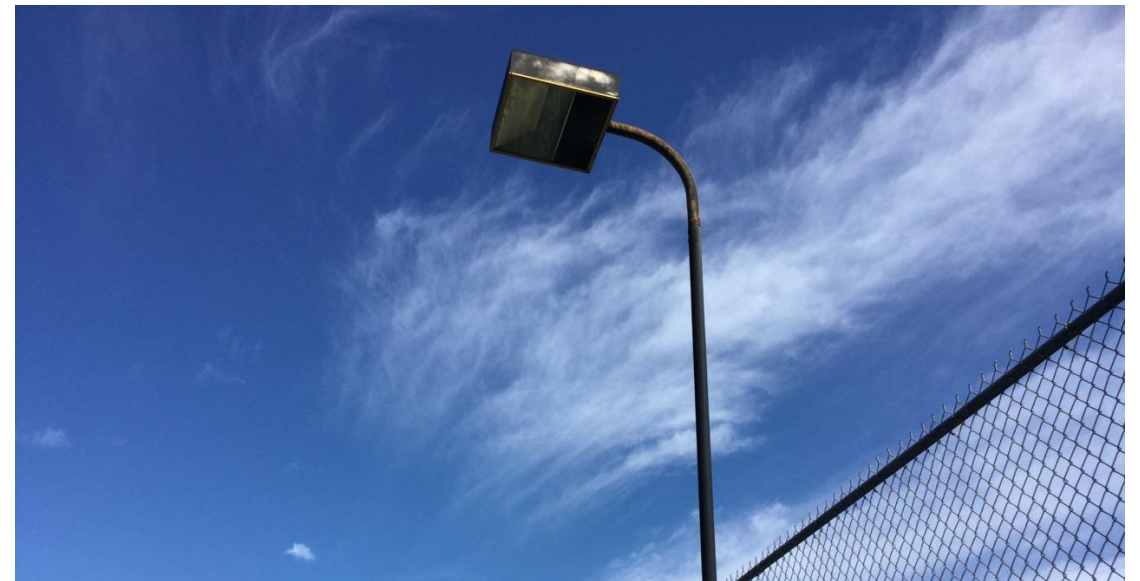
### Tennis Complex – Overall Fair Condition

- Playing surface is in **poor condition** – last resurfaced in 2013
  - Cracking has started to occur on every court
  - Surface as been degraded by pine needles accumulating
- Lighting is in **fair condition** as the light poles are beginning to rust and are metal halide

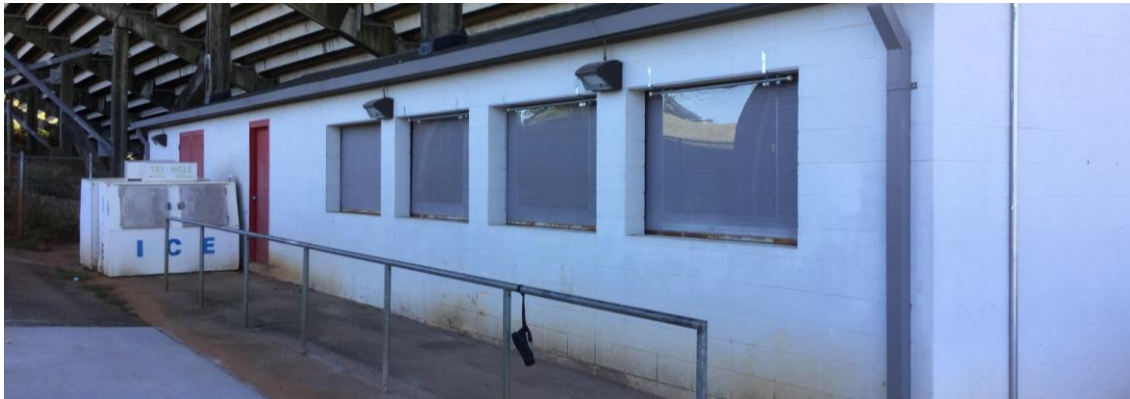
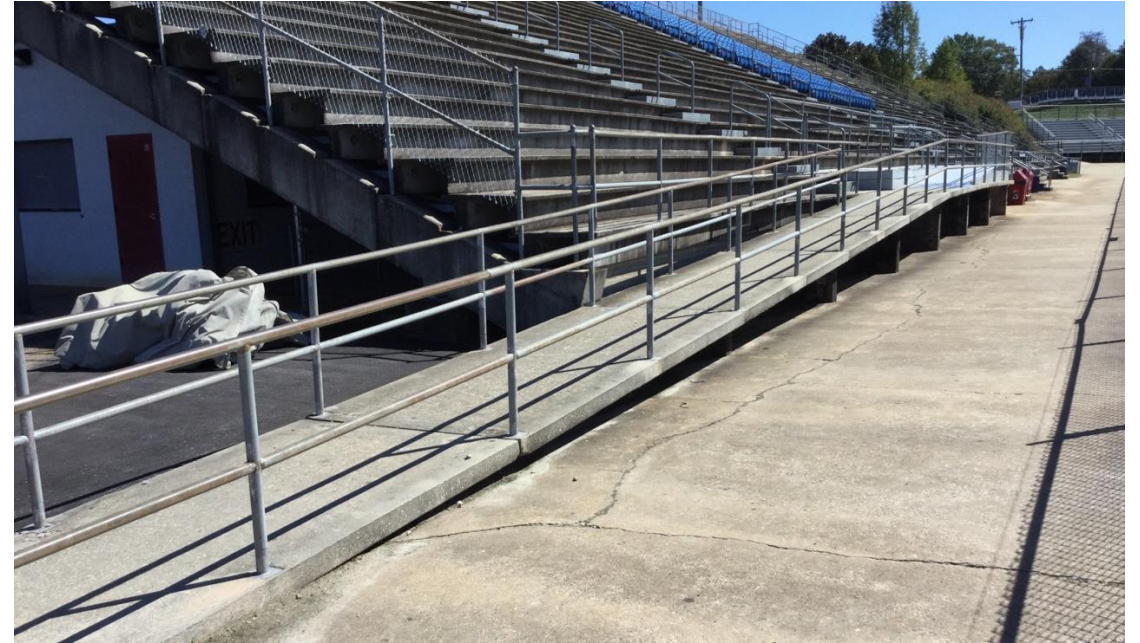
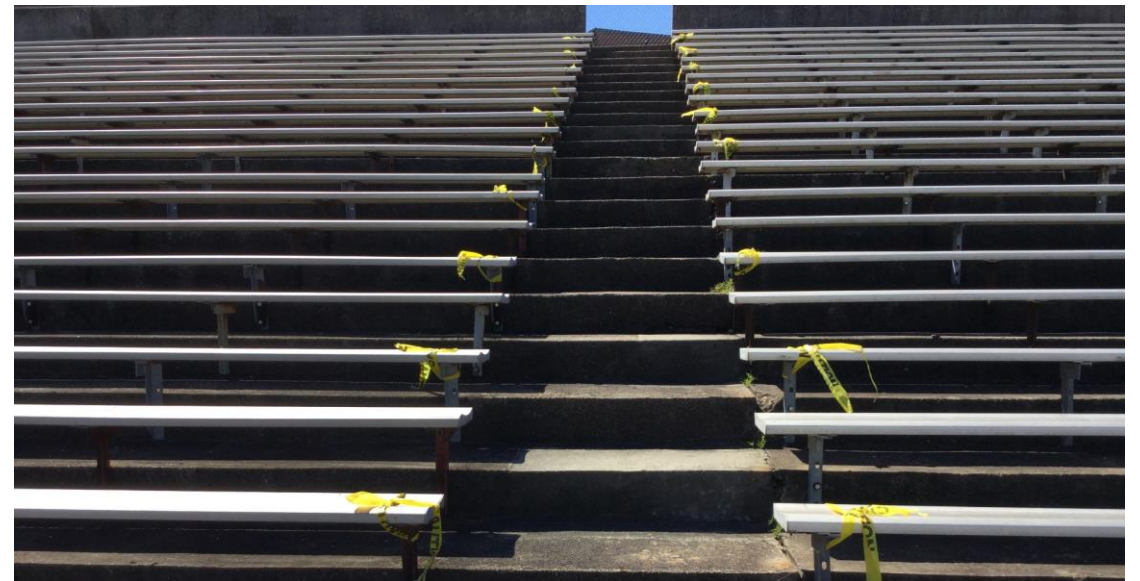
### Byrnes High School Football Stadium – Overall Fair Condition

- Overall ADA compliance is in **poor condition**
  - No accessible path to the home handicap seating area
  - No companion seating in handicap areas
  - Handrails do not comply with current building codes
  - Home Concession windows do not comply with ADA
- Spectator seating is in **fair condition**
  - The District has retained a 3<sup>rd</sup> Party to inspect the home spectator seating
  - Stair treads and landings do not comply with the current ADA which requires a visually contrasting nosing.
  - Visitor seating is missing handrails

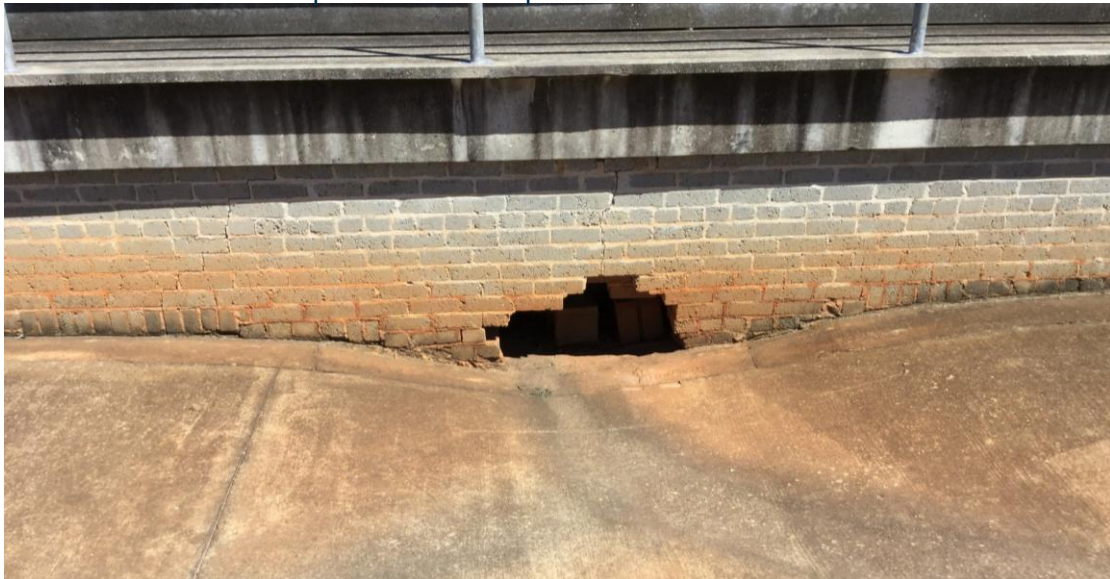
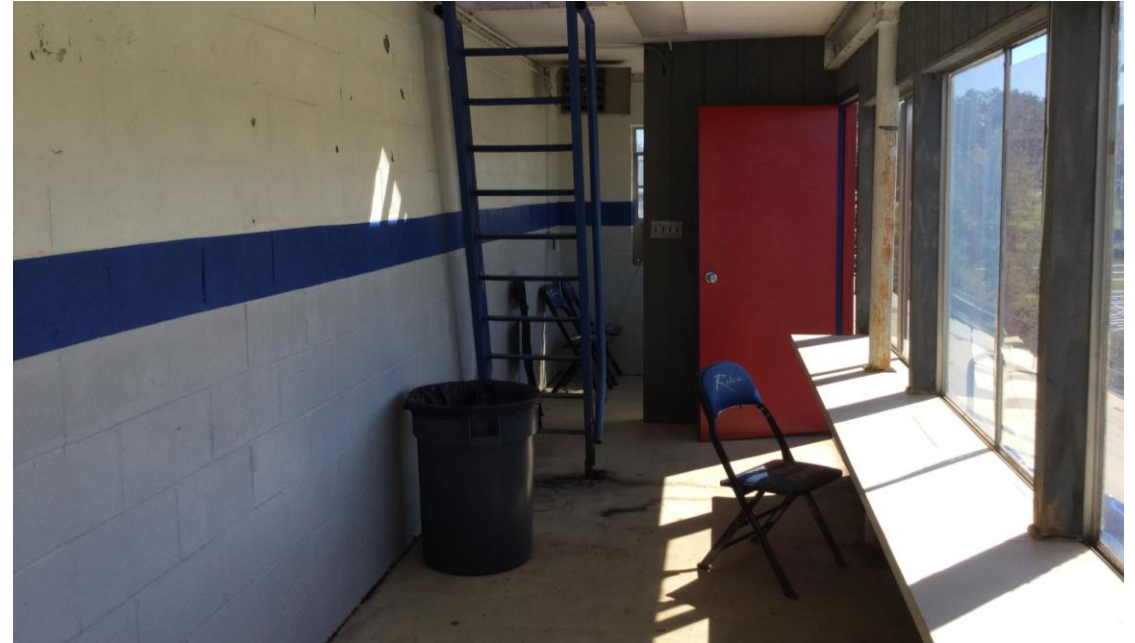
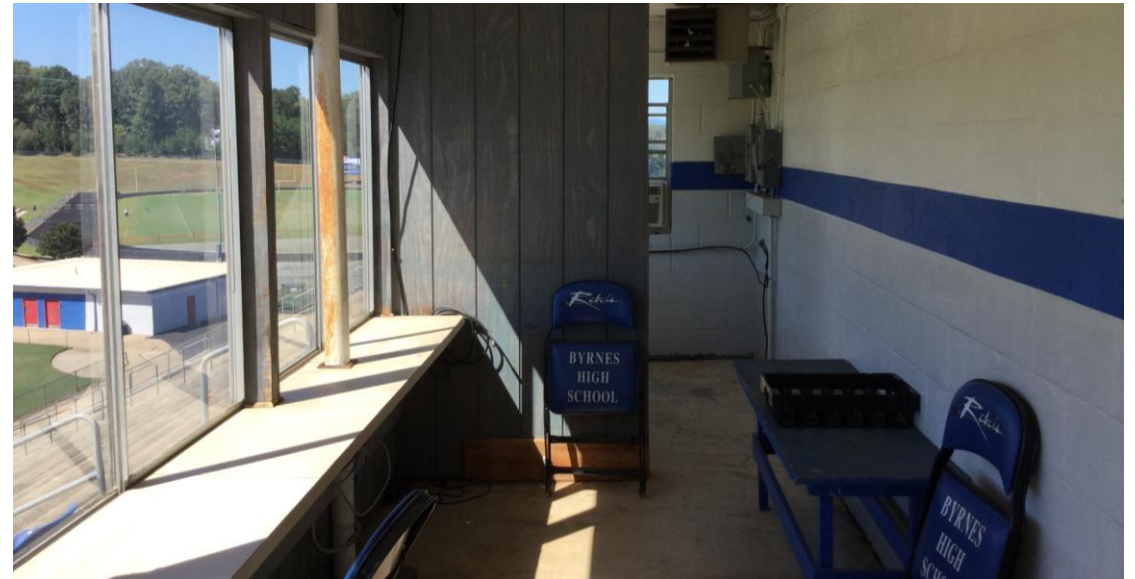
### Byrnes High School Football Stadium – Overall Fair Condition

- Home Press Box is in **poor condition**
  - Not adequate space for required users
  - Required infrastructure for electrical equipment is inadequate
- The Scoreboard / Video Display Board is in **poor condition**. The scoring and timing boards appear to work as normal however, the Video Display Board has developed functional issues and replacement parts have become obsolete.
