February 25, 2013

Facilities Review

FACILITIES REVIEW
DISTRICT FIVE SCHOOLS OF SPARTANBURG COUNTY

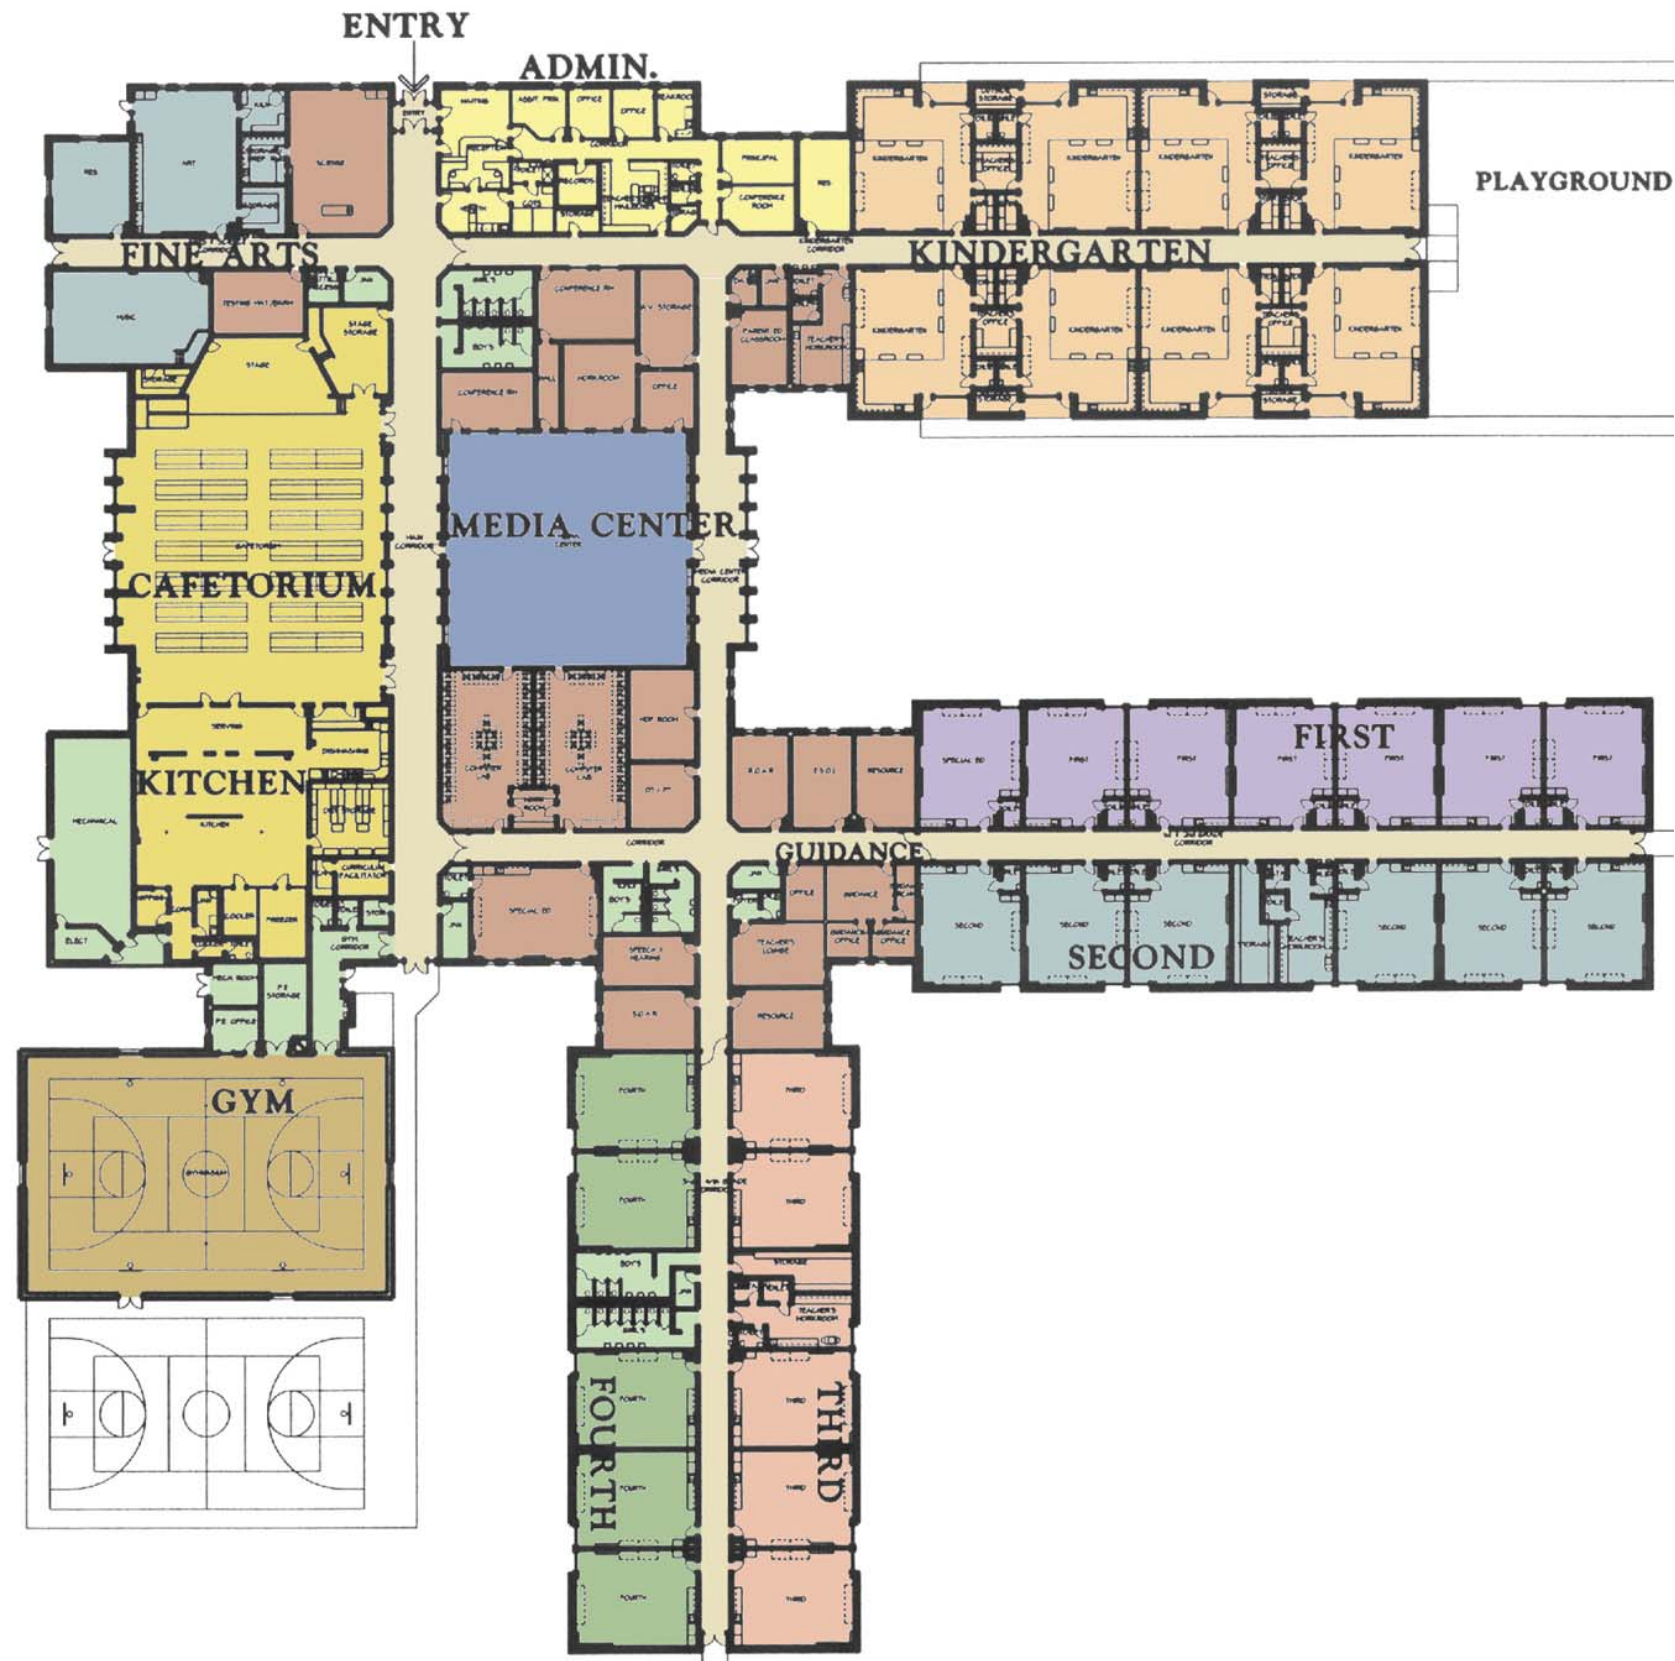
Lyman Elementary Existing Floor Plan

1. **Tier One** – Newer facility approximately five years old
2. No significant issues with building systems or accessibility
3. Main entrance has security vestibule.
4. All corridors between classrooms and support areas are enclosed.
5. Cafetorium can seat approximately 450 per lunch period.
6. Classroom wings have expansion capability.

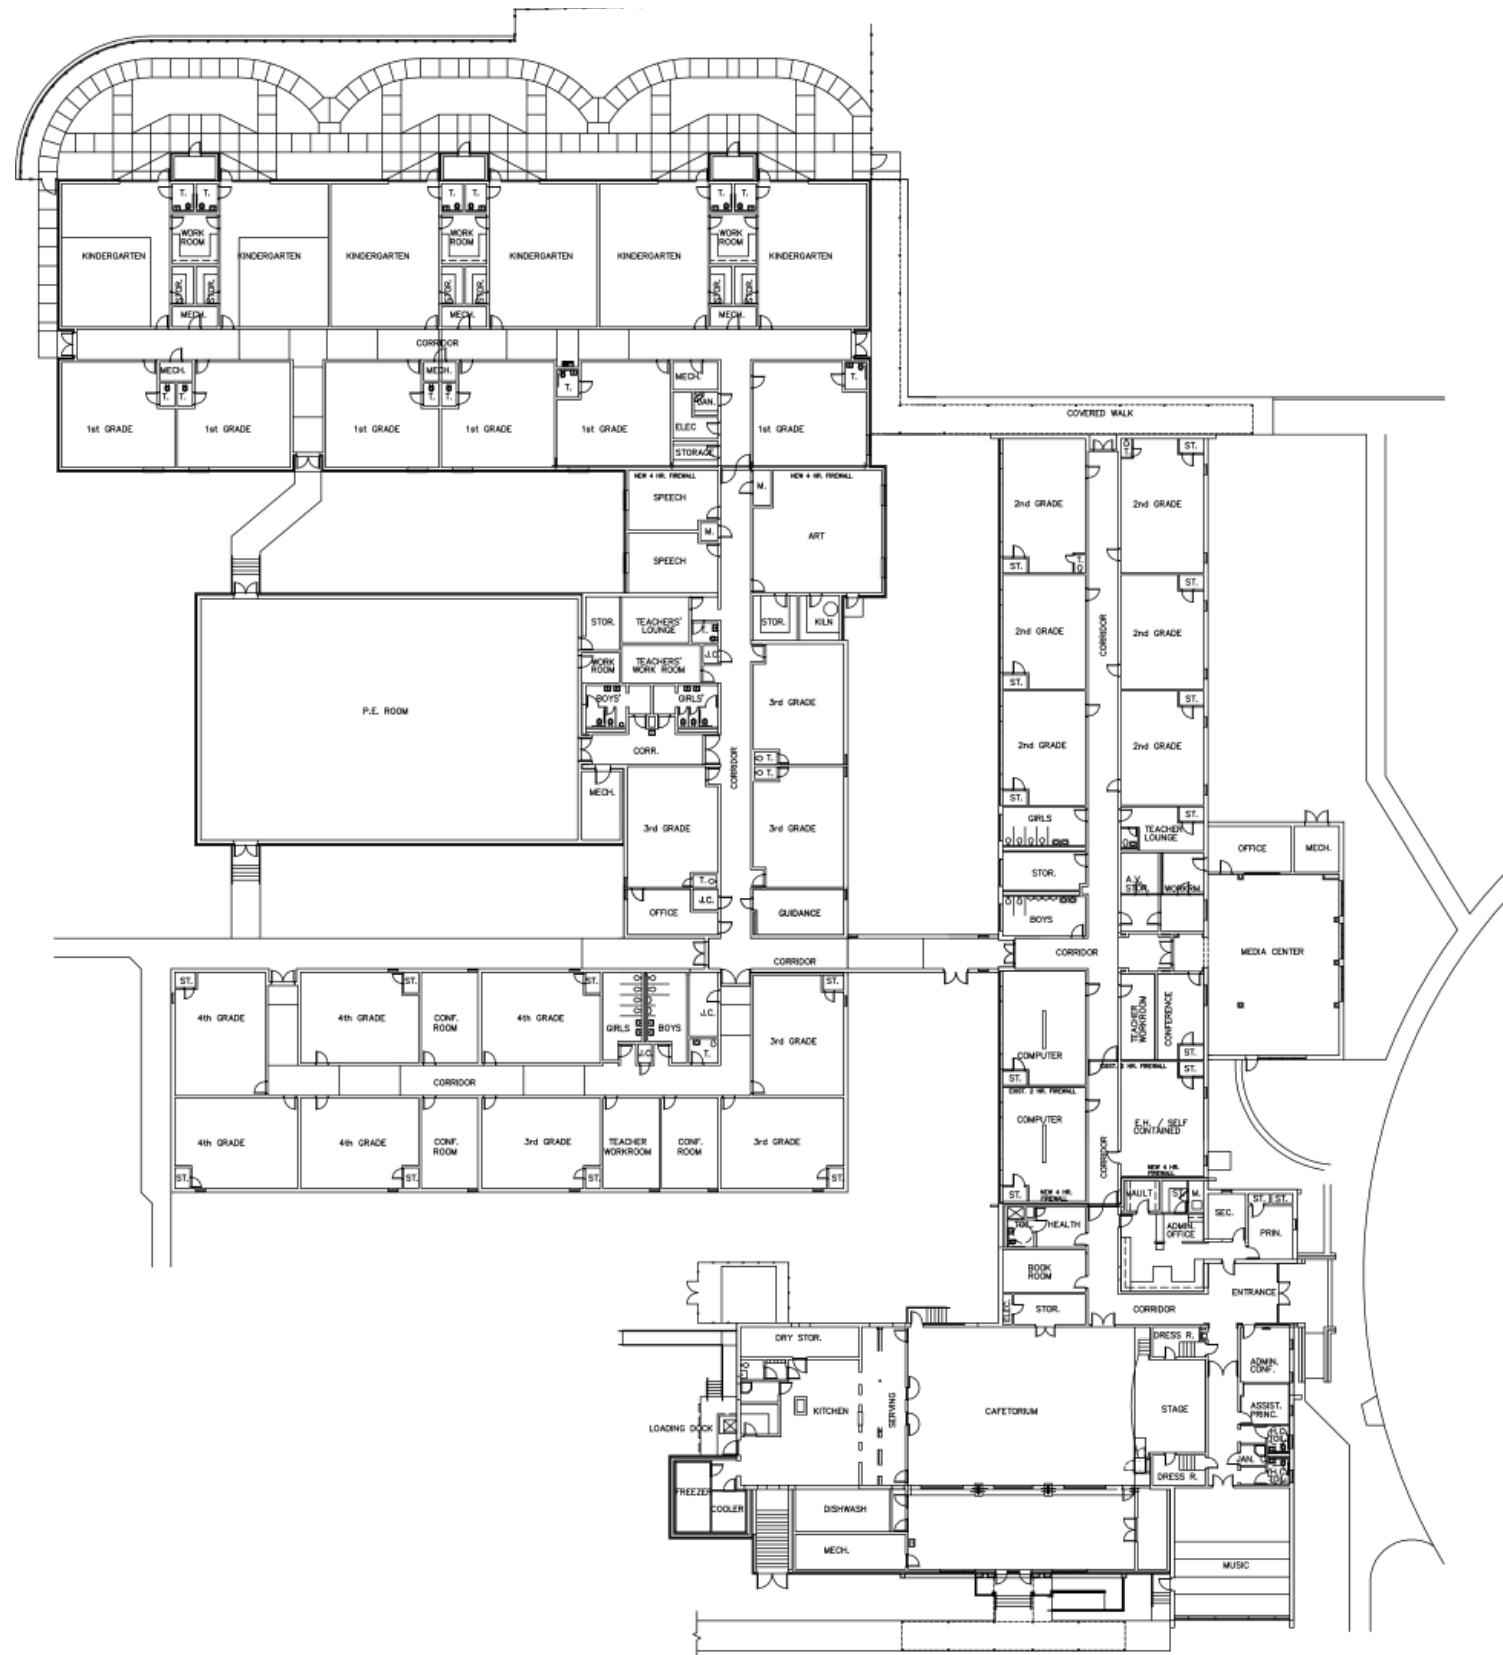
Wellford Academy of Science + Technology (Title One) Existing Floor Plan

- **General Condition:**
 1. **Tier Three** – Older facility with combination of Synthetic Stucco finish in some areas, brick masonry in others. The stucco (or EIFS) appears to have had some issues with drainage to the interior side of the wall system.

3. The roof has obvious signs of prior patching and requires frequent repairs. Needs new gutters and work performed on fascia/eave.
4. Main entrance has airlock, but not a true security vestibule.
5. Corridors between classrooms and support areas are enclosed.
6. Cafetorium can seat approximately 330 per lunch period.
7. Some areas of the building have steps within the exit discharge.
8. Exterior fascia/eave has wood trim that should be replaced in some areas.
9. Equipment room located in basement makes maintenance more difficult to access.
10. Exterior metal canopy appears to have some defects at the left side of building when faced from street.
